**[Docket No. FAA-2026-2712; Project Identifier AD-2025-00931-T; Amendment 39-23483; AD 2026-20-10]**

### **Airworthiness Directives; The Boeing Company Airplanes**

**2026-20-10 The Boeing Company:** Amendment 39-23483; Docket No. FAA-2026-2712; Project Identifier AD-2025-00931-T.

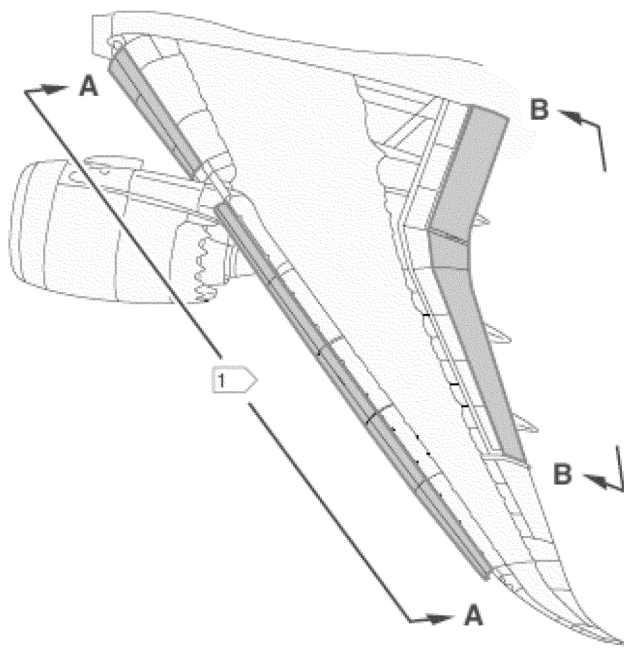
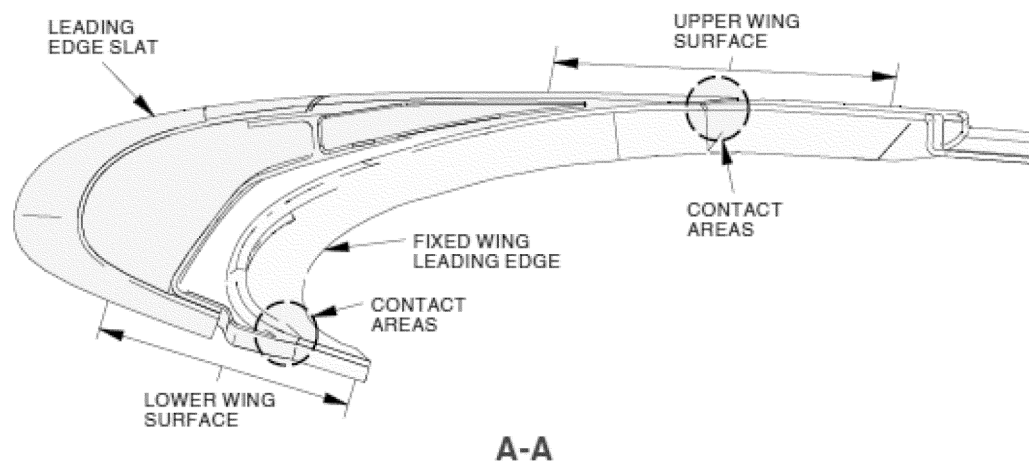
Figure 2 (Sheet 1 of 3) Slat and Flap Inspection

1 INSPECT ENTIRE LENGTH OF LEADING EDGE SLATS  
AND FIXED WING LEADING EDGE IN THIS AREA
