## EASA Safety Information Bulletin

**SIB No.:** 2009-11  
**Issued:** 24 April 2009

**Subject:** Operation with Emergency Flotation System ARMED.

**Subject: Note for operation with emergency flotation system**

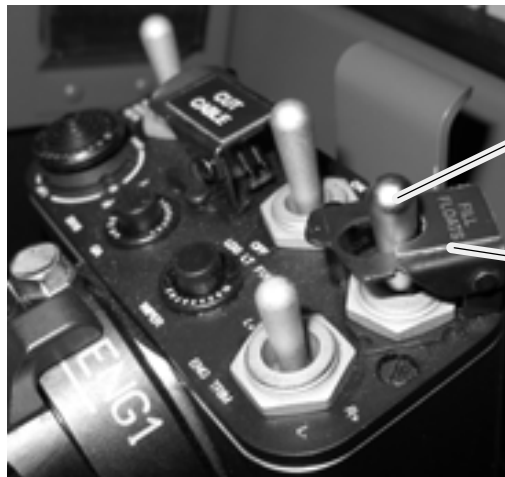
Switch **"FILL FLOATS"**

- a maximum airspeed **of 80 kt** must not be exceeded i.a.w Flight Manual Supplement FMS 9.2-67.
- an incorrect securing of switch **"FILL FLOATS"** (1) and its protective cap (2) at the collective lever on the ground might, under unfavourable circumstances, cause an unintentional release of the emergency flotation system during flight.

If the maximum airspeed is exceeded and the emergency flotation system is unintentionally released, the flight attitude can extremely change. Thus, the controllability of the helicopter might no longer be ensured. Furthermore, it also might occur that the emergency floats are detached from the helicopter.

It must be ensured that the switch (1) re-engages in the **"OFF position"** after it has been operated. The **"FILL FLOATS"** switch must not be reset to its initial position by pressing or closing the switch's protective cap (2).
