**[Docket No. FAA-2026-2712; Project Identifier AD-2025-00931-T; Amendment 39-23483; AD 2026-20-10]**

### **Airworthiness Directives; The Boeing Company Airplanes**

**2026-20-10 The Boeing Company:** Amendment 39-23483; Docket No. FAA-2026-2712; Project Identifier AD-2025-00931-T.

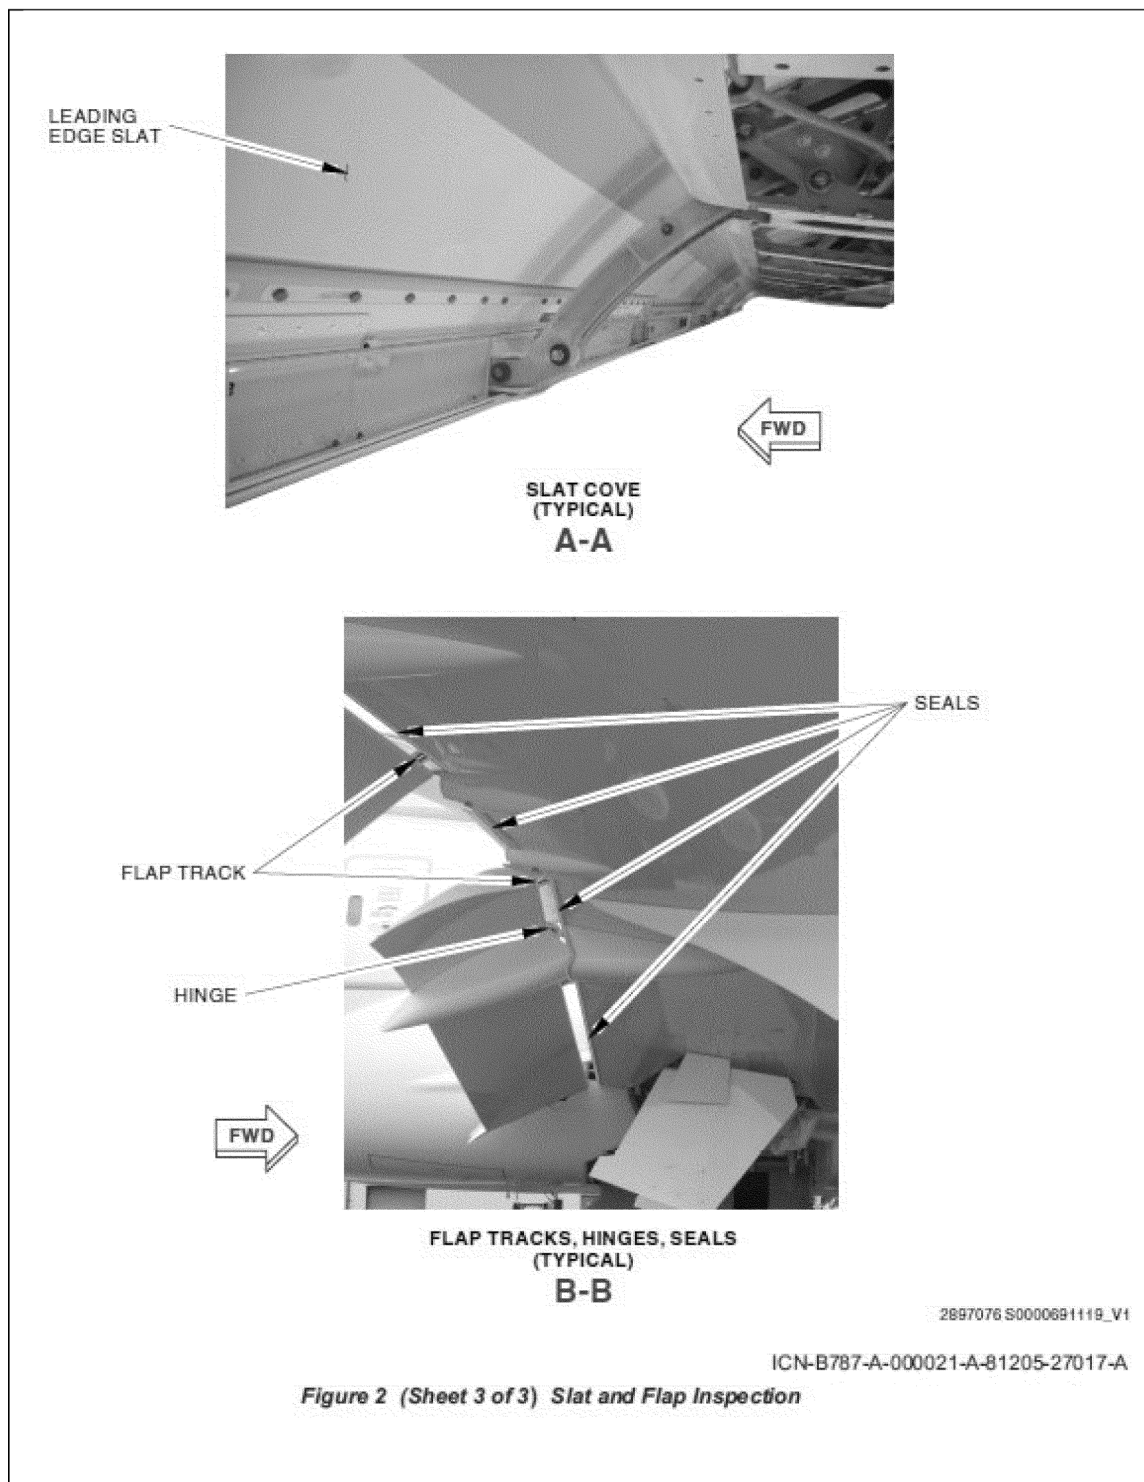
**Figure 2 to paragraph (j): Maintenance or inspection program revision continued**

After any landing in icing conditions, do this inspection with the slats/flaps (flaps 25 detent) fully extended (Figure 2):

- (a) Confirm a contaminant-free condition in these areas immediately prior to retraction of the slats/flaps surfaces.

This paragraph restates the requirements of paragraph (j) of AD 2019-20-07, with no changes. Within 60 days after October 11, 2019 (the effective date of AD 2019-20-07), revise the existing maintenance or inspection program, as applicable, to incorporate the information specified in figure 2 to paragraph (j) of this AD. This may be done by inserting a copy of figure 2 to paragraph (j) of this AD into the existing maintenance or inspection program.
